# Manhole Inspection Summary

Manhole # S13II1036MH

Insp Date: **6/15/07 8:27 AM**

**Location** Address: **COLD SPRING LN**

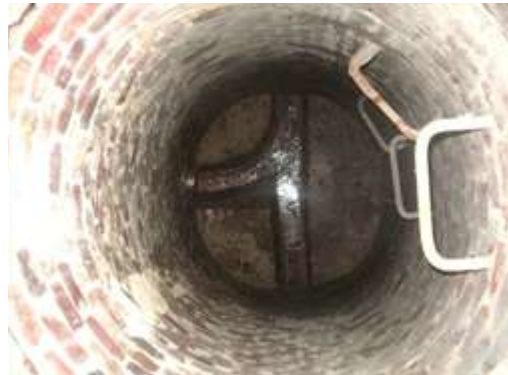
Top View

Corroded steps. Evidence of surcharge - Bench debris.

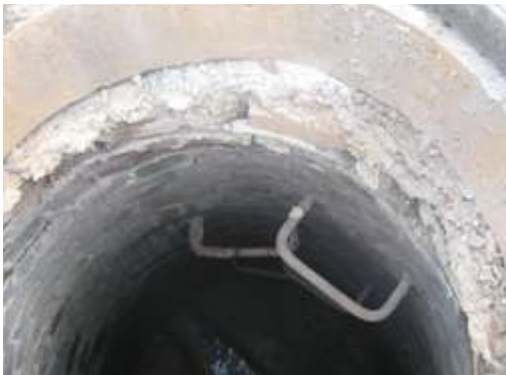
Defect

Frame leaks. Frame offset. Adjustment deterioration and infiltration.

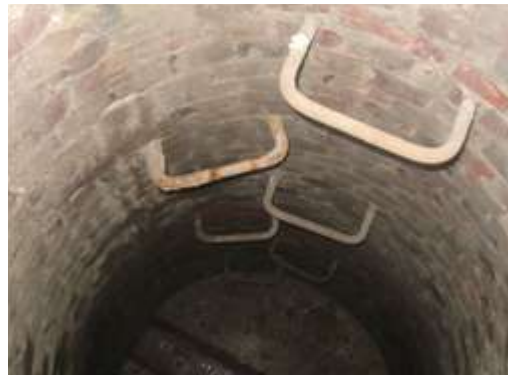
Defect

Adjustment and Barrel infiltration.

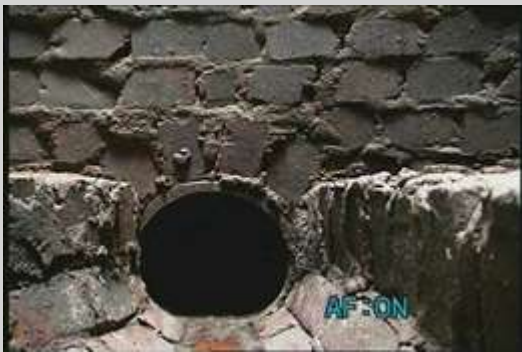
### 8 in. Circular Gravity Sewer Pipe Out @ 12 O'Clock

Barrel deterioration and infiltration. Channel deterioration.

Infiltration: **Evidence** Pipe Seal Cond: **Unknown**

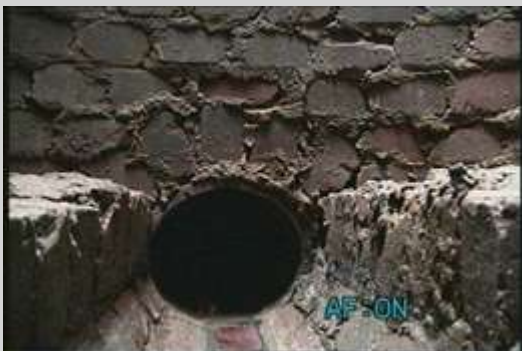
### 8 in. Circular Gravity Sewer Pipe In @ 6 O'Clock

Barrel deterioration and infiltration. Channel deterioration.

Infiltration: **Evidence** Pipe Seal Cond: **Unknown**
